Characterization of Indoor Hygrothermal Conditions in Houses in Different Northern Climates

ABSTRACT

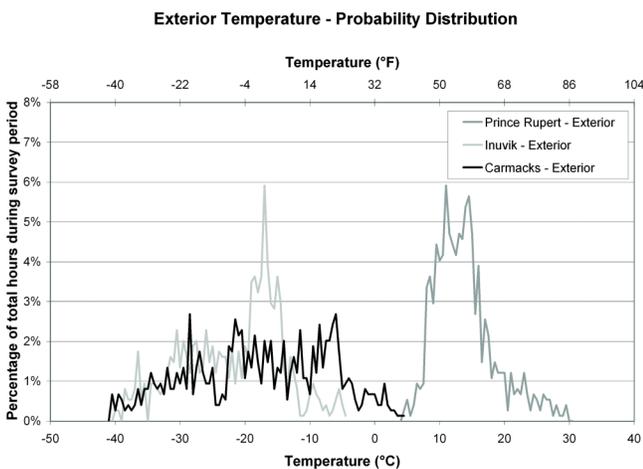
Figure 2 Distribution of outdoor temperature measured during the one-month survey period in each location.

Northern coastal climates (i.e. cool and very humid) and northern climates (i.e. very cold and dry) were included in the surveys. Table 1 provides some outdoor climate data from the survey sites. Figure 2 shows the outdoor temperature prevailing during the survey periods using probability distribution curves.

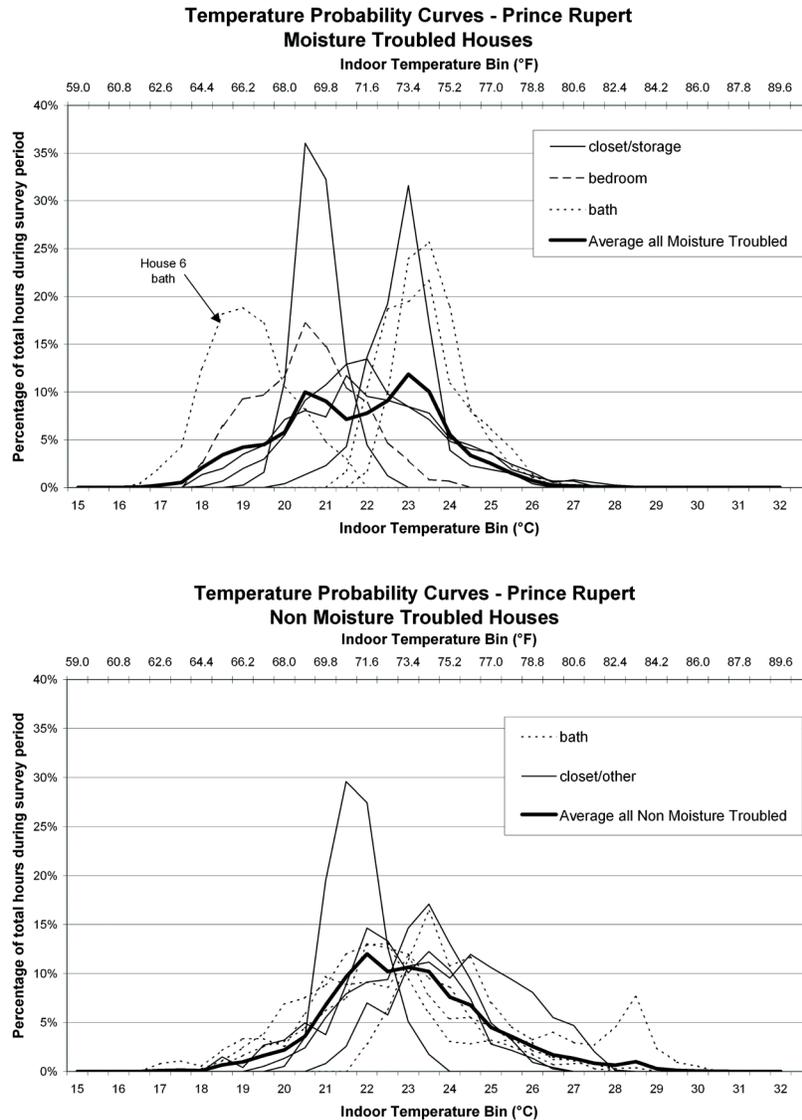
Figure 3 Distribution of indoor temperature measurements for the one-month survey in Prince Rupert BC. The legend on the right-hand side corner of the graph provides the room where the sensor was located.

Indoor Temperature. In the mild and wet climate of Prince Rupert (in springtime), average daily indoor temperatures were widely spread between 15°C and 32°C (59 and 90°F) (Figure 3). Bathrooms in houses with moisture problems operated at much lower or higher indoor temperature for longer periods than the houses without reported moisture problems. Other surveyed spaces included closets and storage rooms (moisture problems were reported at these locations), and in some cases these spaces operated at cooler temperatures than living spaces. For instance, the house no. 6 (3 occupants) bathroom operated between 16 and 22°C (61 and 72°F), did not have a bathroom exhaust fan and experienced recurrent moisture problems such as mould growth on the bathroom ceiling.

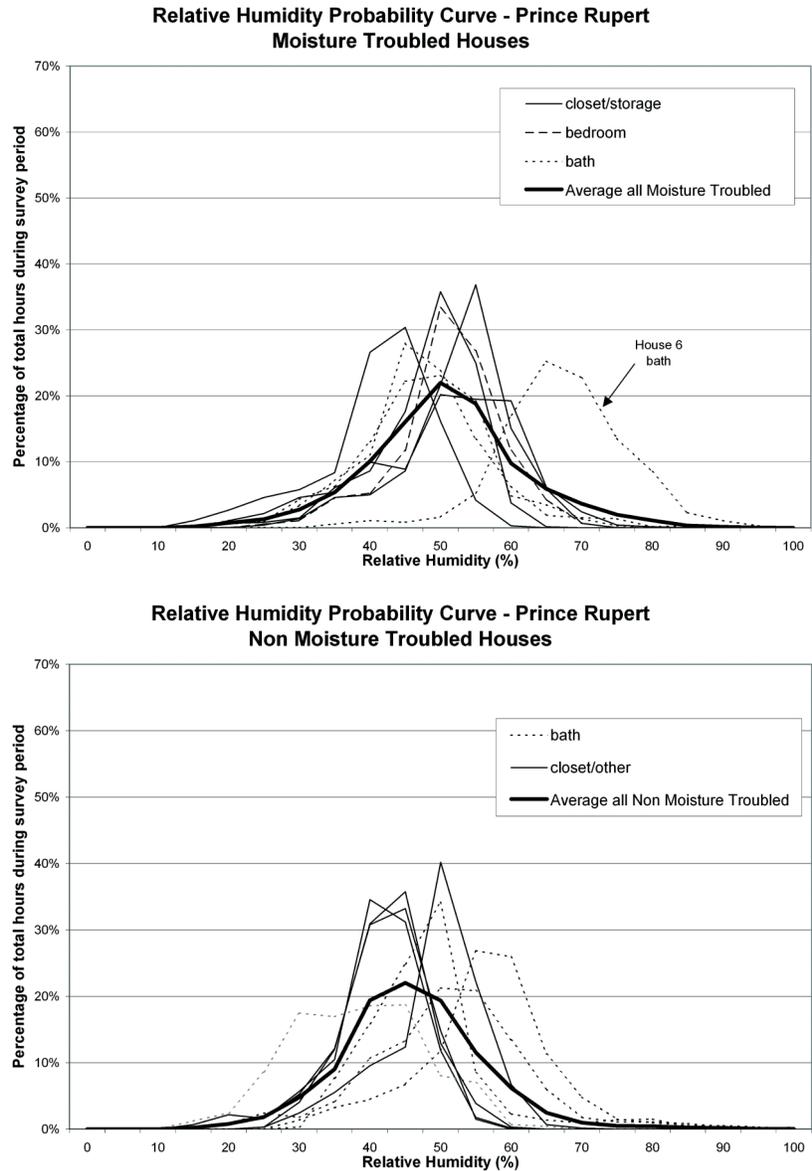
Figure 4 Distribution of indoor RH measurements during the one-month survey in Prince Rupert, BC. The Legend on the right-hand side corner of the graph provides the room where the sensor was located.

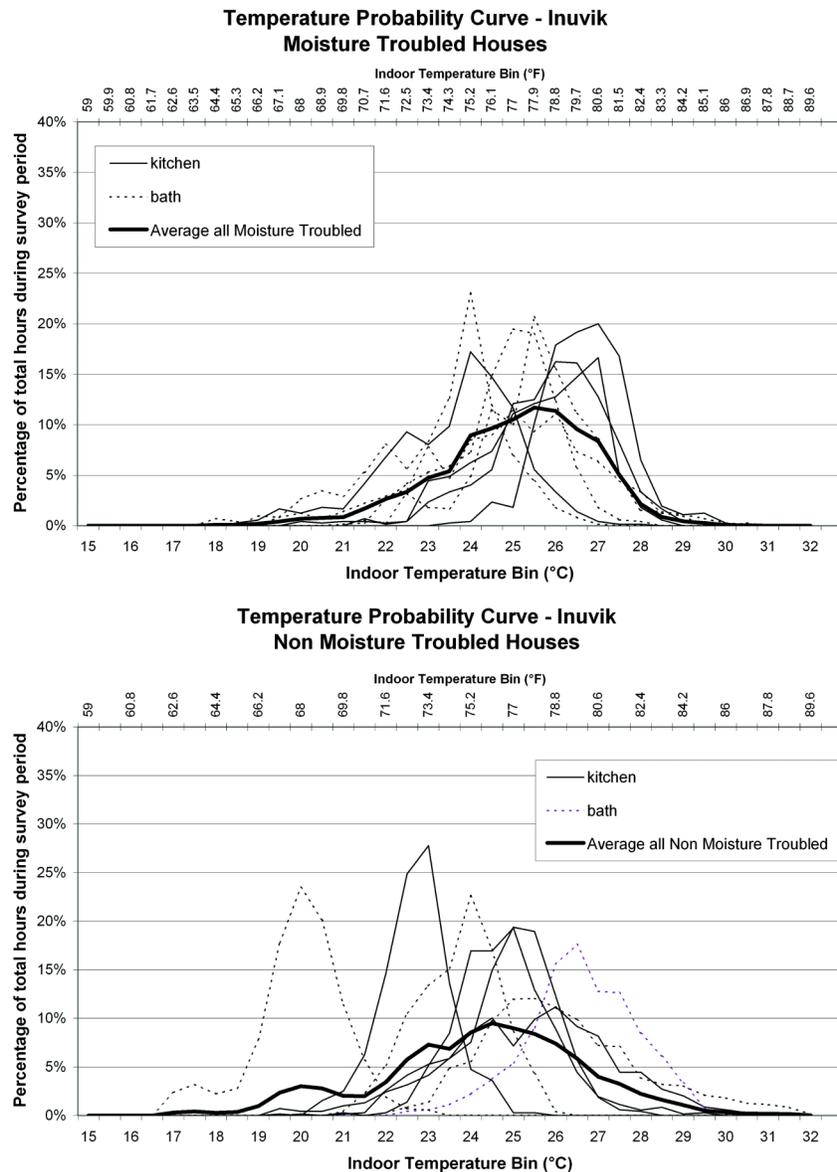
Figure 5 Distribution of indoor temperature measurements during the one-month survey in Inuvik, NT. The legend in the box in the upper part of the graph provides the room where the sensor was located.

Indoor Temperature. In general the houses surveyed operated at higher temperature (the average was 25.5°C [77.9°F]) than the other two surveys (Figure 5).

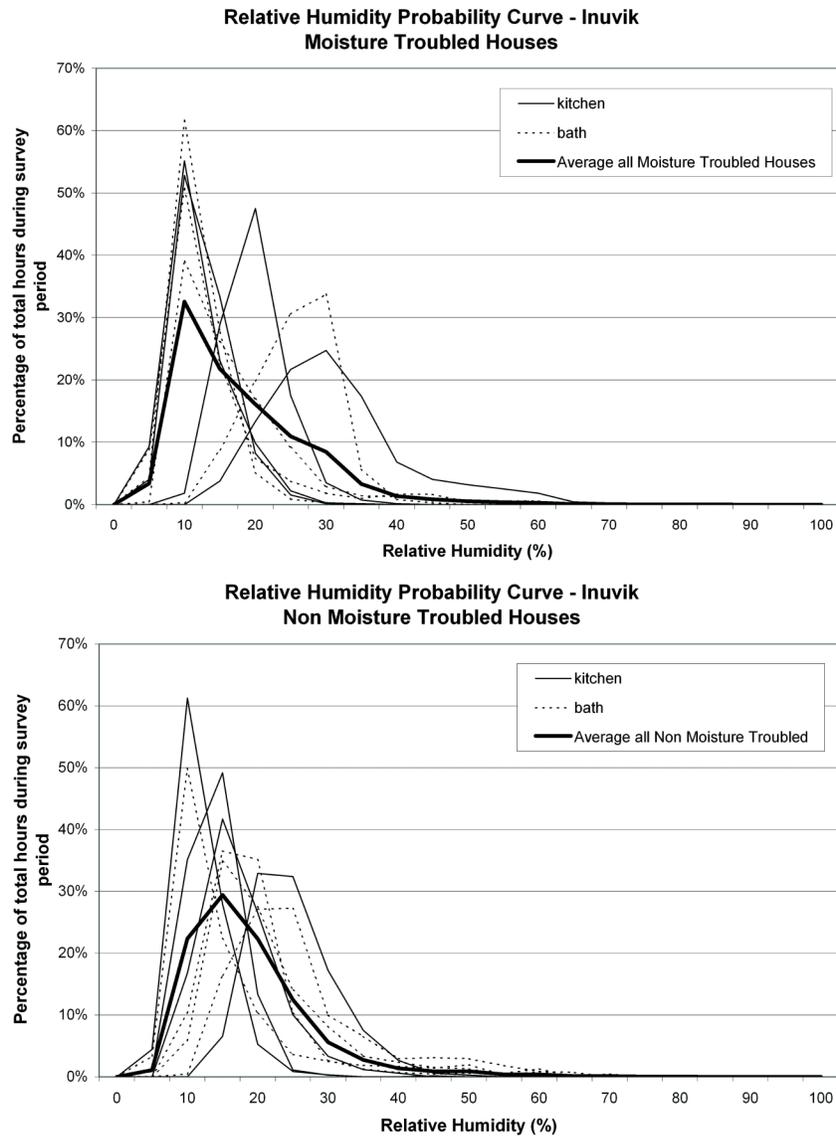
Figure 6 Distribution of indoor RH measurements from the one-month survey in Inuvik, NT. The legend in the right-hand side corner of the graph provides the room where the sensor was located.

rences for hourly measurements in each surveyed house are presented in Figure 6. Daily change in the humidity ratio in any of the houses surveyed ranged from 7 to 22 g/kg of dry air (0.0007 to 0.0022 lb_w/lb_{da}). Since bathrooms were surveyed in each house of this survey, data clearly showed that bathrooms were subjected to the largest daily increase in moisture loads, with an average of 19g/kg (0.0019 lb_w/lb_{da}). In such a northern coastal climate, the outdoor air tends to be cool and humid and the difference in humidity ratio between exterior and interior was not large, thus providing a low drying potential for ventilation air; on average the difference in humidity ratio (interior-exterior) during the survey period ranged between 0.7 and 3.3 g/kg (0.0007 to 0.0033 lb_w/lb_{da}).

Indoor Relative Humidity. For the month of the survey, the average relative humidity measured in the surveyed houses was between 9 and 29% RH. Probabilities of occurrences for

the hourly measurements in each surveyed house are presented in Figure 6. The daily change in absolute air moisture content ranged from 6 to 28 g/kg (0.0006 to 0.0028 lb_w/lb_{da}). This can be related to the cold outdoor conditions during the survey period (average: -22°C [-7.6°F], min -41°C [-42°F] and max: -4°C [25°F]), the leakiness of the houses (between 3 and 12 ACH @50 Pa[1.0 lb/ft²]) and the absence of sources of humidification. Bathrooms and kitchen experienced short-term peaks of increased RH, near saturation for bathrooms and up to 85% in kitchens. Moisture problems included dew and frost on double glazed windows and doors as well as on the interface between exterior walls and pene-

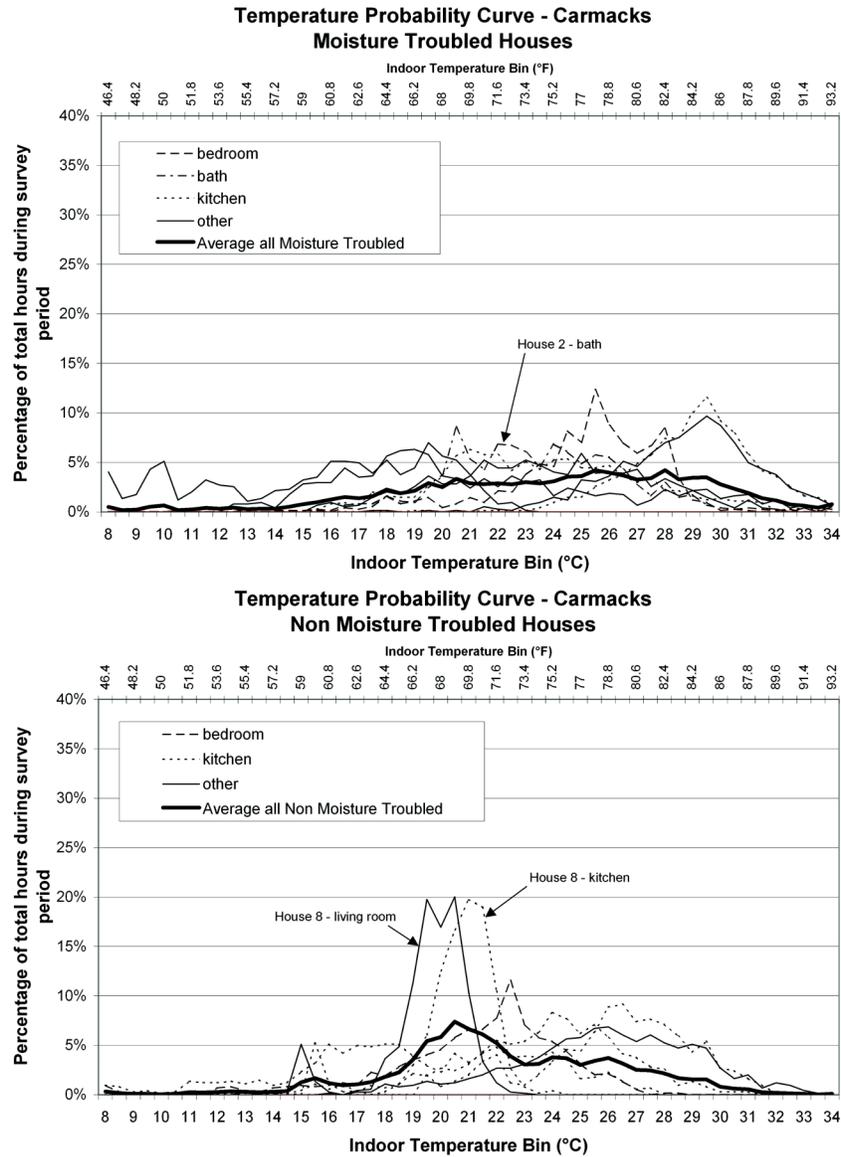
Figure 7 Distribution of indoor temperature measurements for the month of the survey in Carmacks, Yukon. The legend on the left-hand side of the graph provides the room where the sensor was located.

Indoor Temperature. The surveyed houses in Carmacks differ significantly from the other two surveys, in that most of the houses were heated with a central wood-stove, without a heat distribution system - reportedly a decision of the occupants in this First Nations community. This resulted in very large temperature fluctuations in the houses and between rooms - depending on their location in relation to the proximity of the heat source (Figure 7). The spread of daily average temperature for all houses was from 8 to 34°C (46 to 93°F). Kitchens were maintained at a higher temperature than the other rooms (i.e. living rooms and bedrooms). In some cases, 3-minute temperature measurements clearly showed a pattern where the occupant would stoke up the wood stove in the morning and re-stoke it in late afternoon (Figure 8). The only house with a heat distribution system and a furnace (house no. 8) experienced tighter

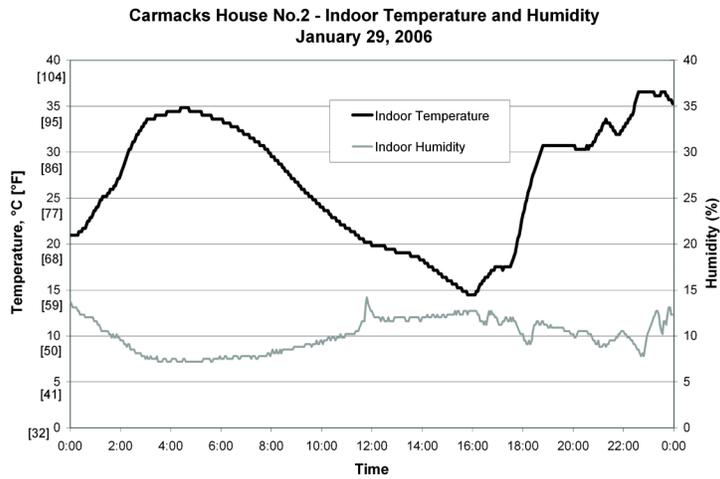
Figure 8 Indoor temperature fluctuations over a 24-hour period in January 2006 in living room of house No. 2 (with moisture problems) occupied by one person.

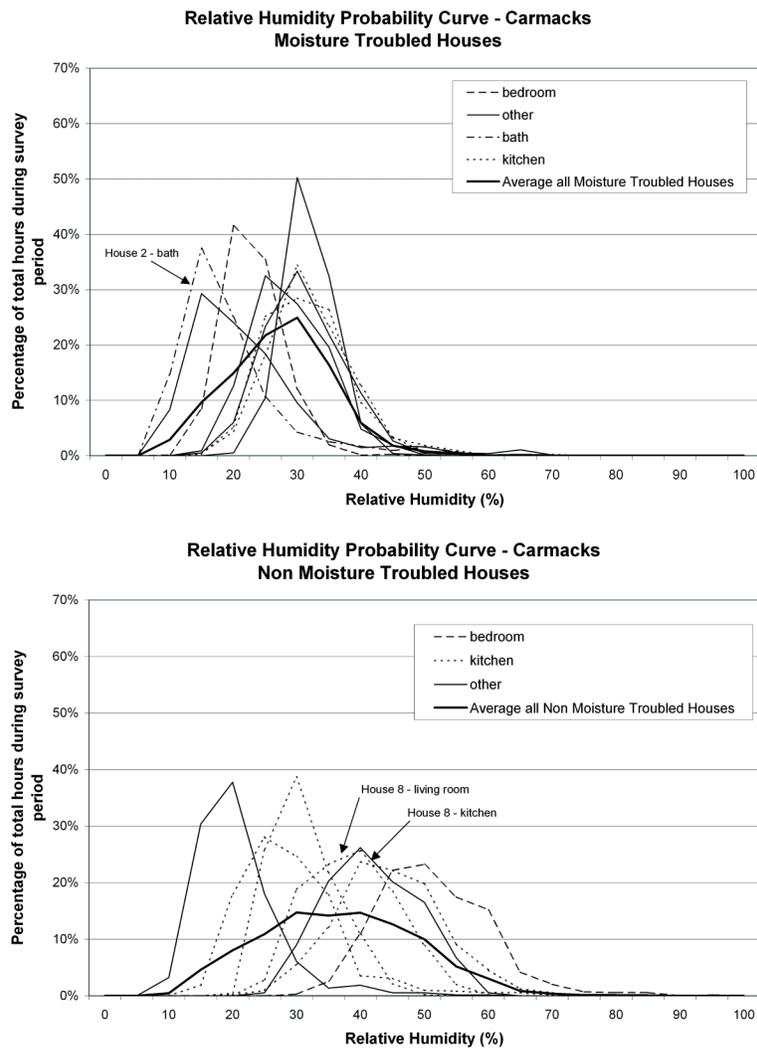
Figure 9 Distribution of indoor RH measurements from the Carmacks Yukon survey. The legend on the right-hand side corner of the graph provides the room where the sensor was located.

Indoor Relative Humidity. For the month of the survey the average relative humidity measured in the surveyed Carmacks YT houses was between 17% and 49% RH. Daily RH averages are plotted in Figure 9. Because indoor temperature fluctuated greatly as well, absolute moisture content in air (g/kg [lb_w/lb_{da}]) provided data on the daily changes in indoor moisture. The probability distribution curves are presented in Figure 9. The maximum fluctuation occurred in the only bathroom surveyed, in house No. 2 (Figure 10). Even though the houses were originally classified as with and without moisture

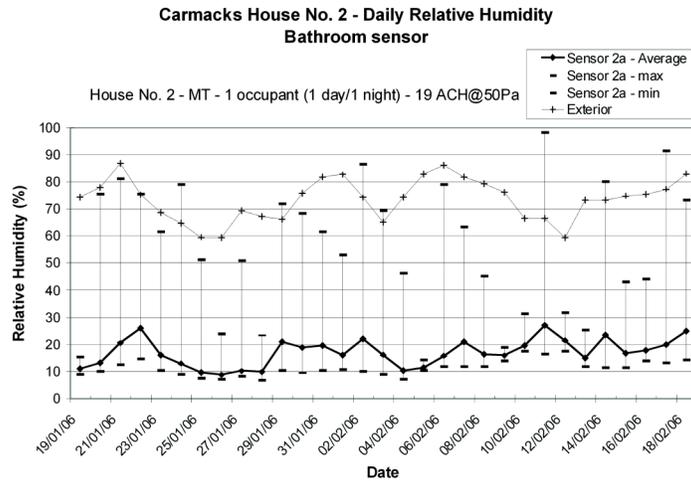
Figure 10 Daily average, minimum, and maximum indoor RH measurements in the bathroom of house No. 2 in the Carmacks, Yukon survey.

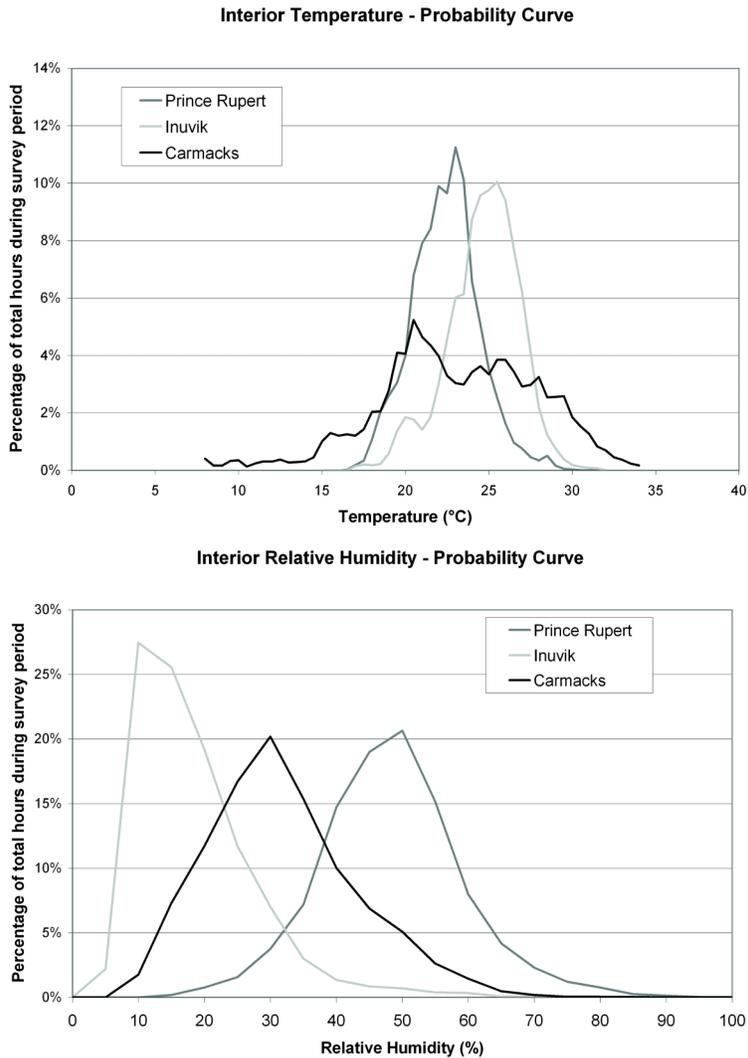
Figure 11 Distribution curves for the hourly average indoor temperature and relative humidity measured in two rooms of eight homes in three regions during the one-month survey.

Figure 11 provides a comparison of the probability of measured indoor temperature and relative humidity for the three surveys.

- The Carmacks YT surveyed houses experienced atypically poor temperature control indoors (Figure 11) due to the absence of a heat distribution system compounded by high air leakage rates through the building envelope. Average RH values in these houses were not considered
