# Sealing of Window and Door Joints in Timber Frame Buildings and Watertightness

Hans Boye Skogstad

Sivert Uvsløkk

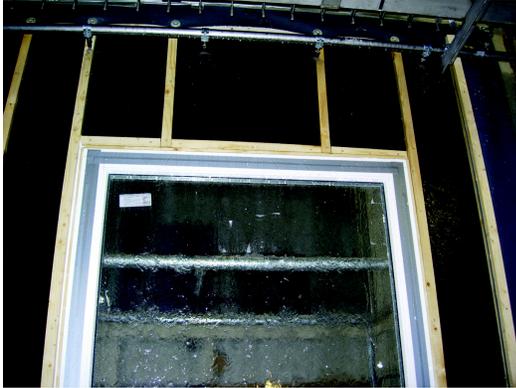
**Figure 1** Nozzles inside the test chamber, spraying water over the test section.

of  $114^\circ$  onto the top of the test section through five nozzles in a rate of approximately 2 L/min per nozzle. The test began with 15 min of spraying water before a static pressure was established across the test section. The watertightness was tested in 10 min on each of the pressures 50 Pa, 100 Pa, 150 Pa, 200 Pa, 250 Pa, 300 Pa, 450 Pa, and 600 Pa. The penetration of water was observed visually during the testing. Location, point in time, and pressure were continuously registered during testing. Figure 1 shows a picture taken inside the test chamber during testing when water was sprayed on the test section.

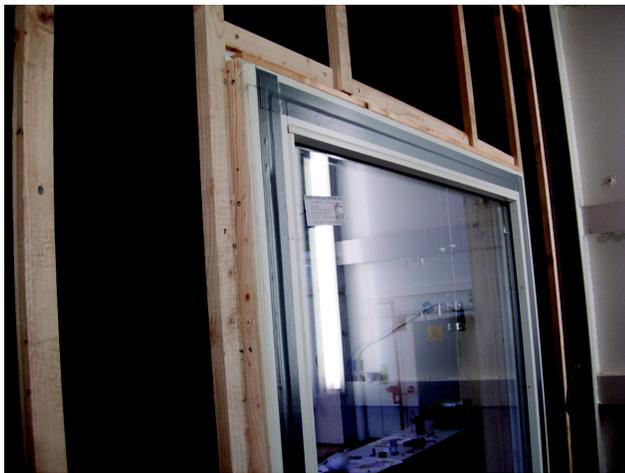
**Figure 3** Test section with wind barrier of asphalt-impregnated fiberboard and window sealed with spun-bonded polyethylene.

assembled in an opening  $1220 \text{ mm} \times 1220 \text{ mm}$ . The wind barrier was applied with both vertical and horizontal joints. The outside window frame was placed 42 mm out from the wind barrier. The timber frame is shown in Figure 2. Figures 3 to 8 show the various test sections in detail. Table 1 summarizes the test sections' characteristics.

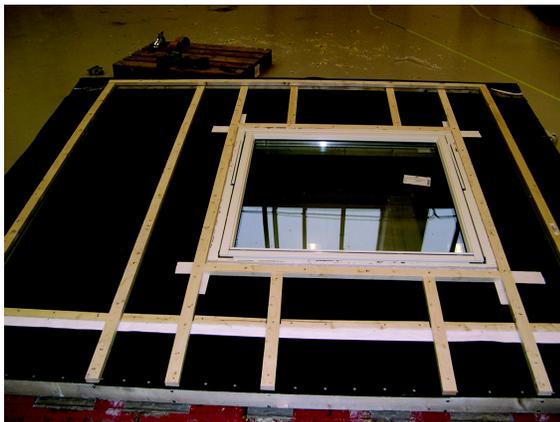
**Figure 4** Test section with wind barrier of asphalt-impregnated fiberboard and window sealed with adhesive tape.

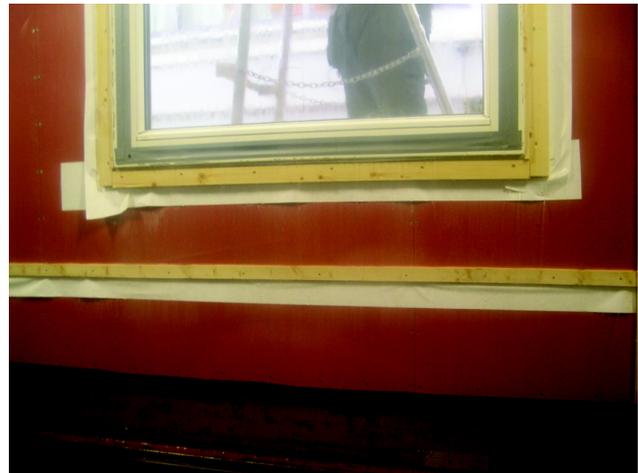
**Figure 5** Test section with wind barrier of gypsum board; window sealed with spun-bonded polyethylene.

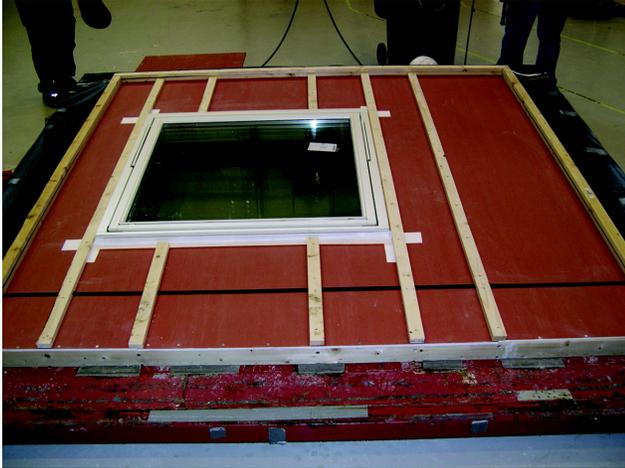
**Figure 6** Test section with wind barrier of gypsum board; window sealed with adhesive tape and horizontal joint performed with plastic H-profile.

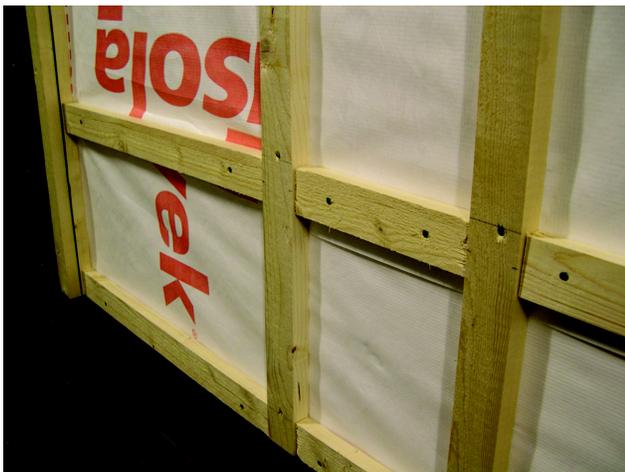
**Figure 7** Test section with wind barrier of spun-bonded polyethylene and horizontal joint performed with 100 mm overlap nailed down with batten.

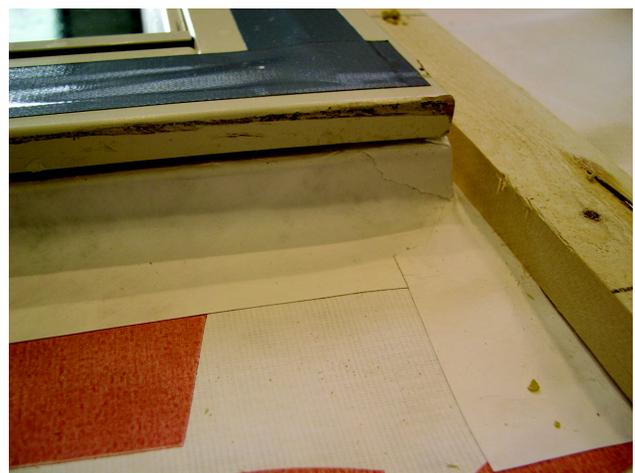
**Figure 8** Test section with wind barrier of spun-bonded polyethylene and window sealed with adhesive tape.
