Residential Exterior Wall Superinsulation Retrofit Details and Analysis

Kohta Ueno

ABSTRACT

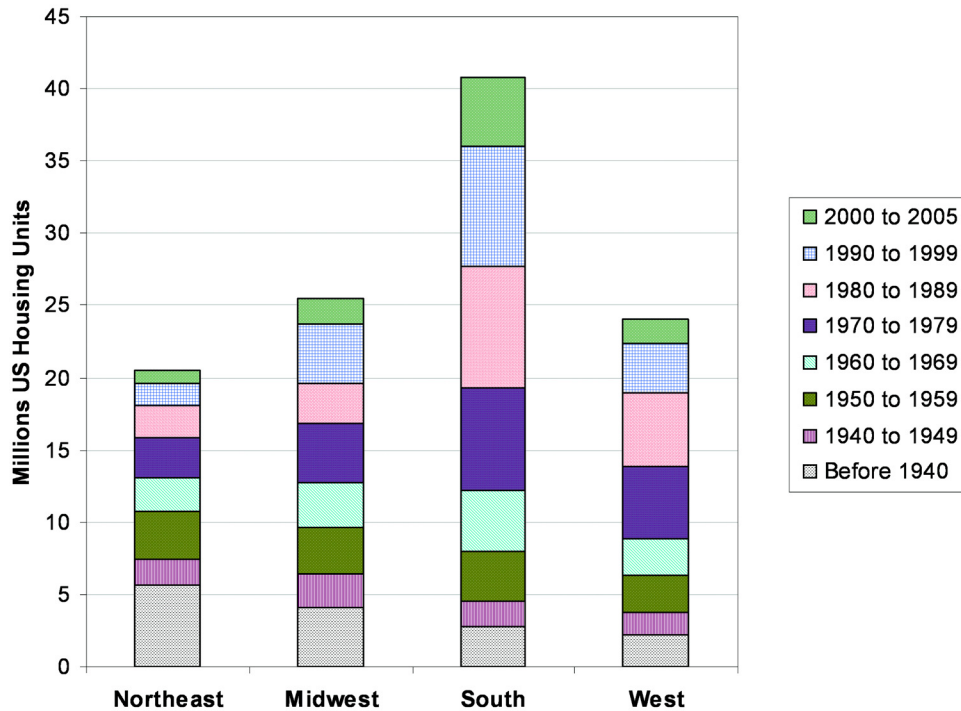
Figure 1 Vintage of US housing units, subdivided by US census region (EIA 2005).

The nationwide distribution of housing stock by geographic census region and age is shown in Figure 1, based on US Energy Information Administration (EIA 2005) data. It demonstrates trends noted by others (Lutz 2004): for instance, much of the oldest housing stock is concentrated in the Northeast, and since the 1970s, the majority of new construction was concentrated in the South and West regions.

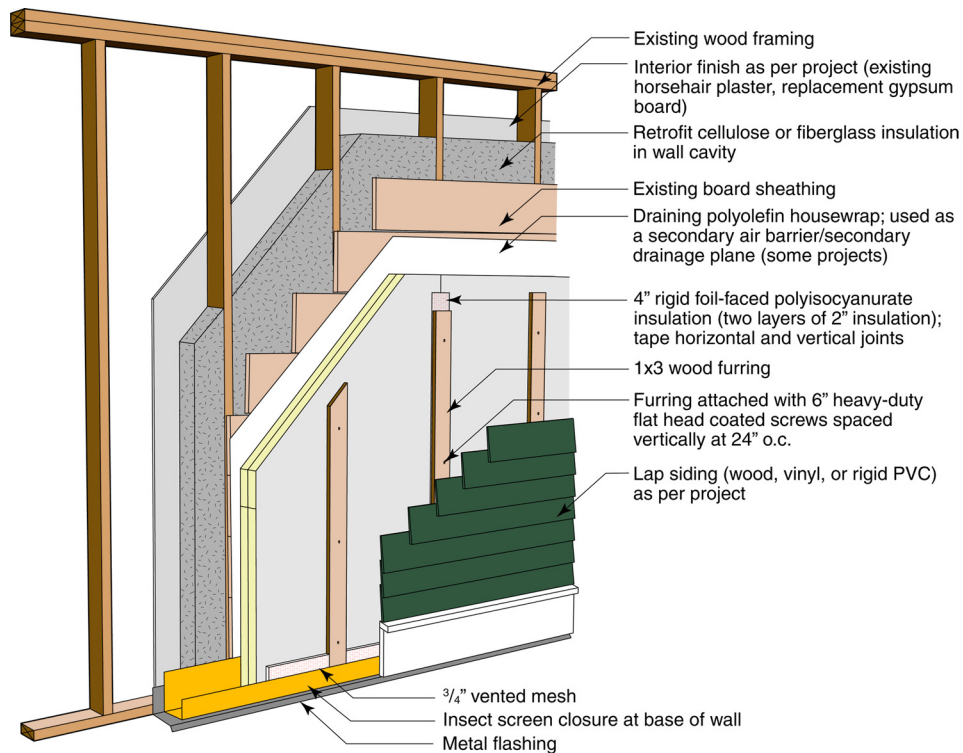
Figure 3 Isometric view of wall retrofit assembly, showing assembly components.

The retrofit wall assembly used in these case studies was largely the same, albeit with slight variations. The wall was composed of the following layers (Figure 3):

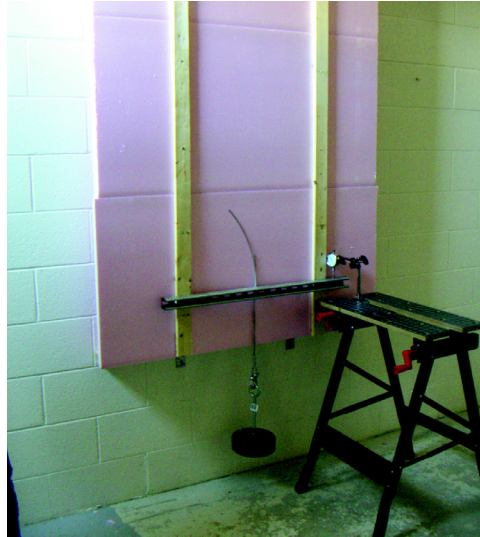
Figure 4 Laboratory mock up testing of deflection with load; 2 in. (51 mm) XPS foam and 1 × 3 strapping, 24 in. (610 mm) o.c.

compression strut forms through the strapping and the foam. This calculation is not performed here; however, laboratory mock up tests were conducted (Figure 4), demonstrating a very high safety factor.

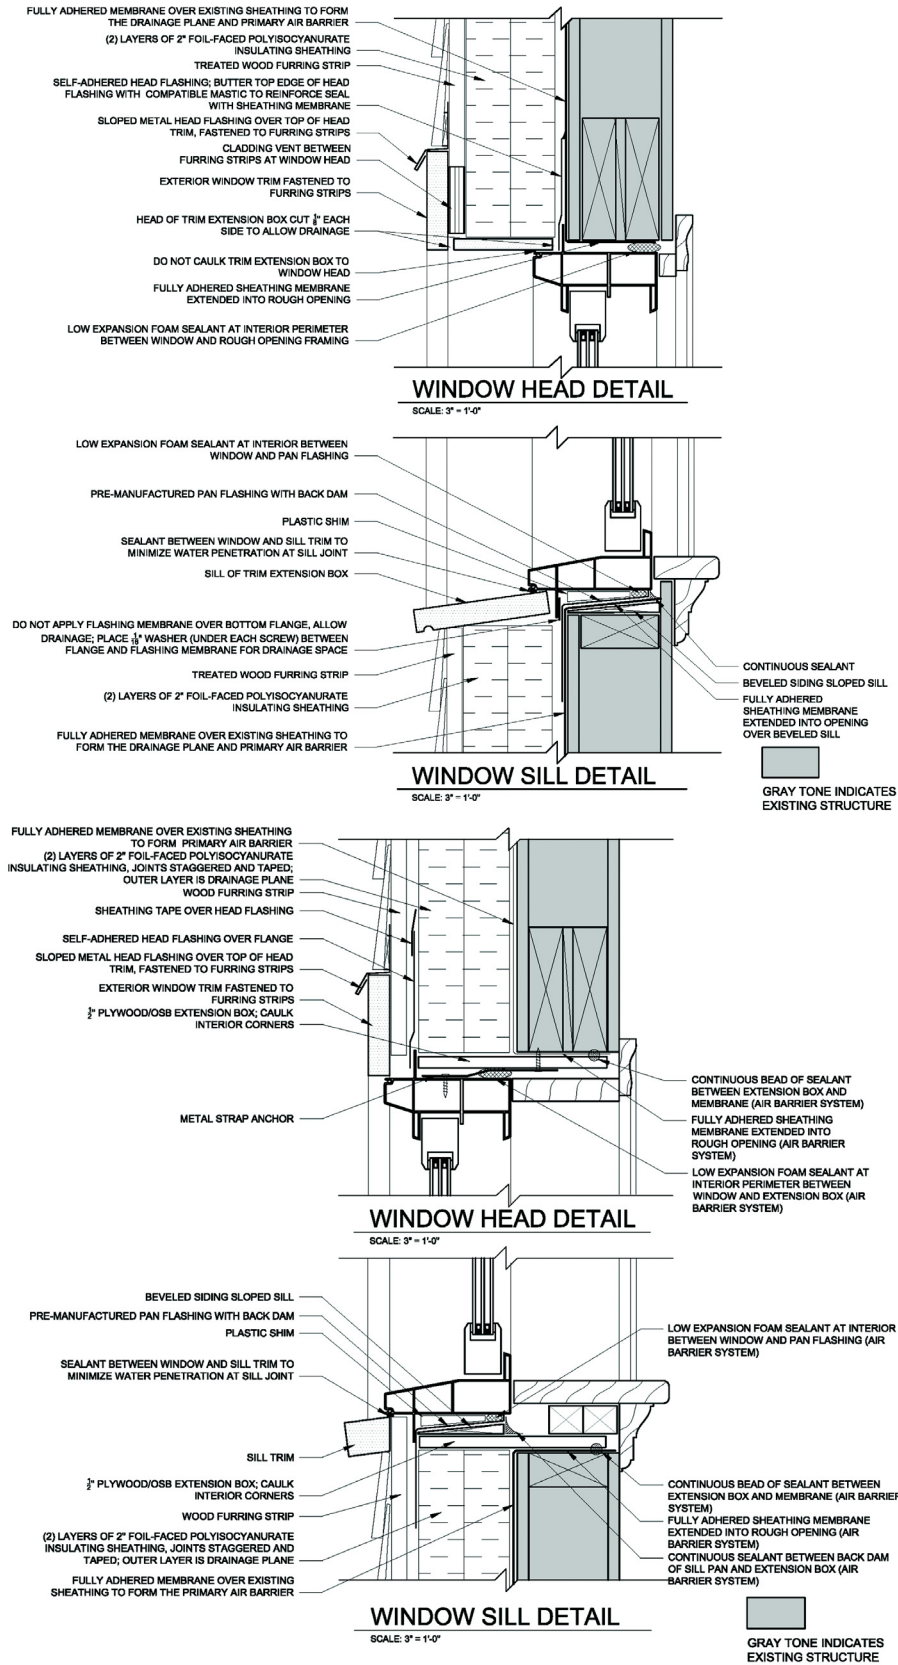
Figure 5 Details of interior (“innie”) window installation (top) and exterior (“outie”) window installation (bottom), showing head and sill details (jamb detail omitted for clarity)

doors and windows require details to account for the resulting deep wells. A window requires some type of sill extension to account for the wall thickness: the window plane location in the wall can be towards the exterior (colloquially known as an “outie” window), or towards the interior (“innie” window). An exterior window is detailed with an extension “box,” to provide solid attachment for the window in the plane of the nonstructural foam. An interior window requires exterior jamb, sill, and head extensions, which need to be exterior-grade materials. Basic details of both of these options are shown in Figure 5; complete details with construction sequencing will be published in the future. Benesh (2009) and Holladay (2009) discuss of the pros and cons of the two options. It should be noted that the choice is also influenced by the location of the primary water control layer/drainage plane, as the connection between the window drainage system and the wall’s drainage plane is critical.

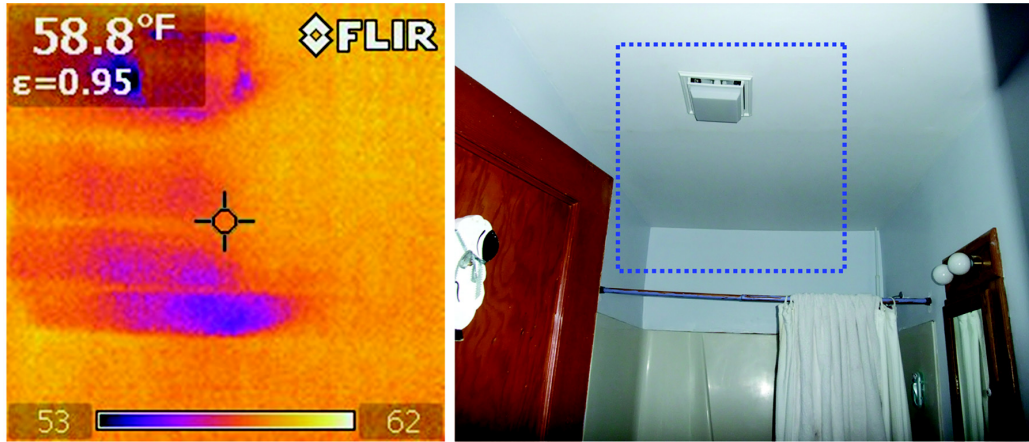
Figure 6 Air infiltration visible at bathroom exhaust fan; exterior wall beyond shower. Infrared image shows strapping/furring at ceiling, perpendicular to joists, supporting lath and plaster.

- **Mechanical:** Several mechanical exhaust fans proved to be significant leakage locations, including the kitchen range hood at the Concord Four Square and the bathroom exhausts at the Arlington Duplex, as shown in Figure 6. In addition, leakage bypassing the backdraft damper is visible. It is not clear whether the leakage occurs at the exterior penetration, or via leakage of the exhaust duct within the joist cavity.

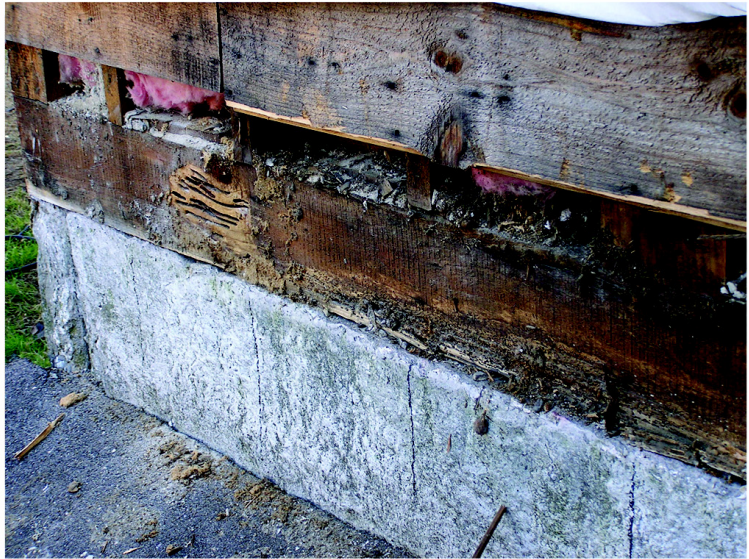
Figure 7 Sill detail, including air barrier transition wrapped to front of foam, and capillary break over foundation (left); existing sill beam, showing long-term moisture damage (right).

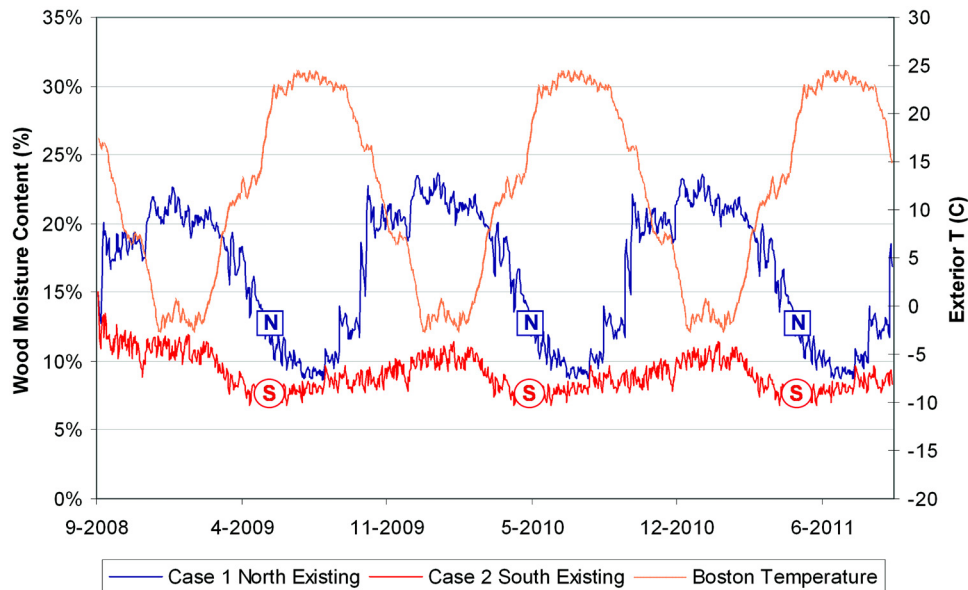
Figure 8 Existing wall with 0.5% of incident rain penetration, north and south exposures, with exterior temperature for reference (seasonal patterns).

When the rain penetration was reduced to 0.5% of rainfall, the results are shown in Figure 8 (with the exterior temperature to show seasonal patterns): moisture contents peak in wintertime to 23%, and dry to below 10% in summertime, with a seasonally stable pattern.

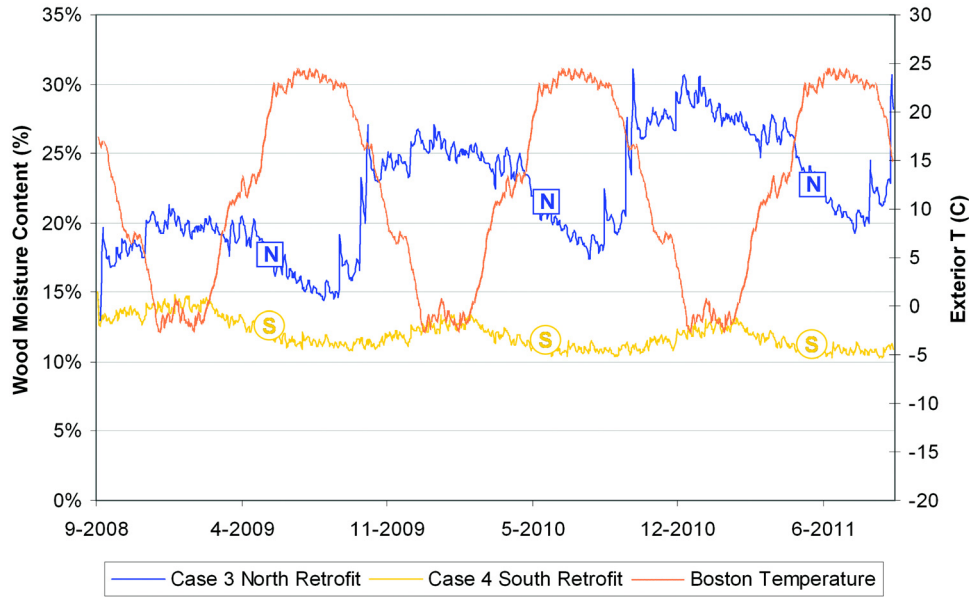
Figure 9 Retrofitted wall with 0.5% of incident rain penetration, north and south exposures, with exterior temperature for reference (seasonal patterns).

However, when these same rain penetration levels are applied to the retrofitted wall (Figure 9), the north side shows a seasonally increasing moisture content, exceeding 30% by the third winter. This indicates a greater sensitivity to rain penetration. If the rain penetration is reduced by half (to 0.25%), the moisture content of the north-side sheathing stays at safe levels, with lower peak moisture contents relative to the original wall (peaks at roughly 17%).
