Metals and Ceramics Division

IRIDIUM-ALLOY PROCESSING EXPERIENCE IN FY 1989

E. K. Ohriner

Date Published: November 1990

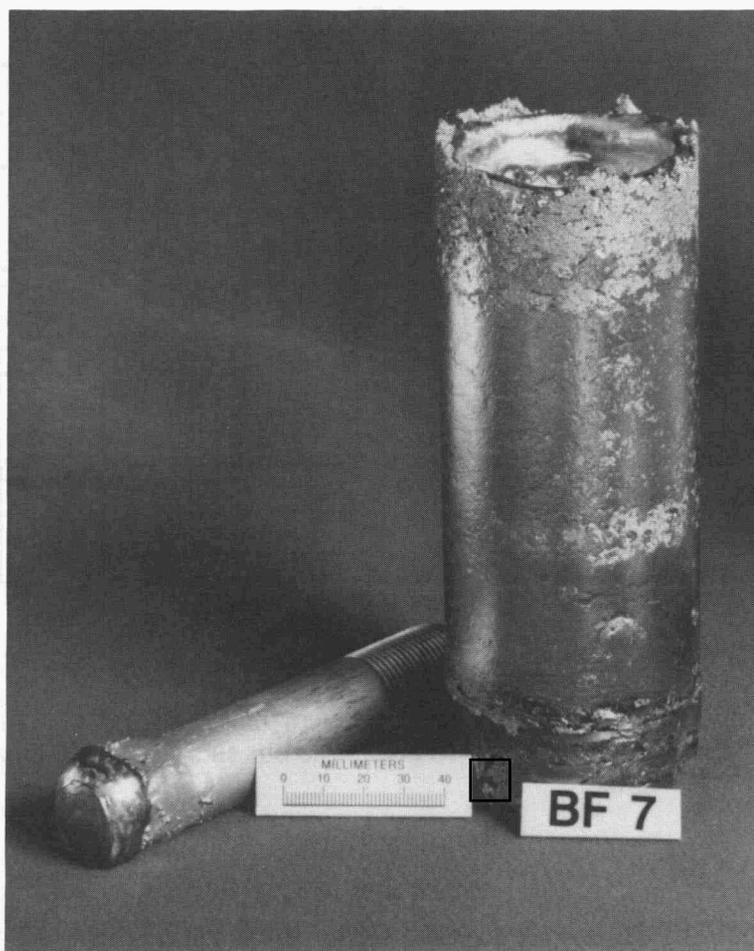
Fig. 4. The BF7 ingot showing uniformly smooth surface appearance and relative short skull height at the top of the ingot.

The BF7 ingot, shown in Fig. 4, has a smooth surface and exhibits no evidence of adherent copper from the mold. The region with the roughest surface corresponds to the small damaged region of the used copper mold. No additional mold damage was observed. The BF7 ingot was cylindrically ground to a 61-mm diam, which resulted in the removal of 0.9 to 1.4 mm from the diameter of casting.
